Metallized Pigment

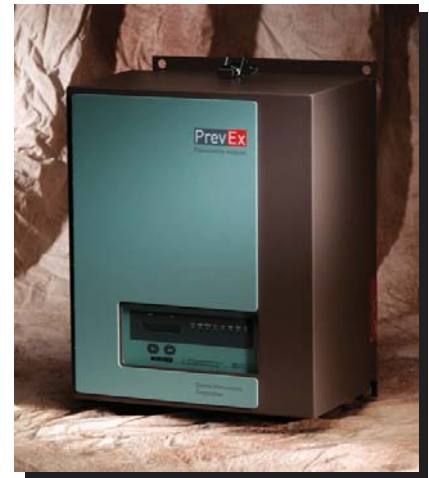
The Company chose to install PrevEx Flammability Analyzers on the drying oven. These analyzers are fully heated to keep all the elements of the dryer atmosphere, including the resins, in the vapor state eliminating clogging and sample condensation. They are industrial strength analyzers that feature fast response, failsafe operation, low maintenance and easy servicing.
